DSTO-TN-0073

Experimental Stress Analysis of a Plate
Containing an Elongated Hole to
Determine Buckling Behaviour Under
Representative F-111C Loading
Conditions

**Airframes and Engines Division
Aeronautical and Maritime Research Laboratory**

Executive Summary

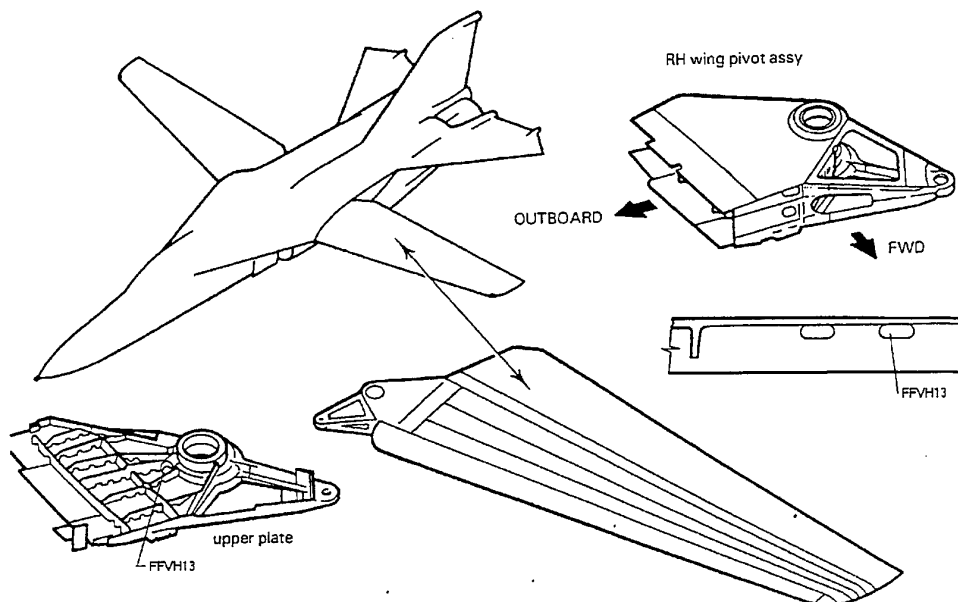
Figure 1: F-111 Aircraft & wing, showing location of critical hole, FFVH13

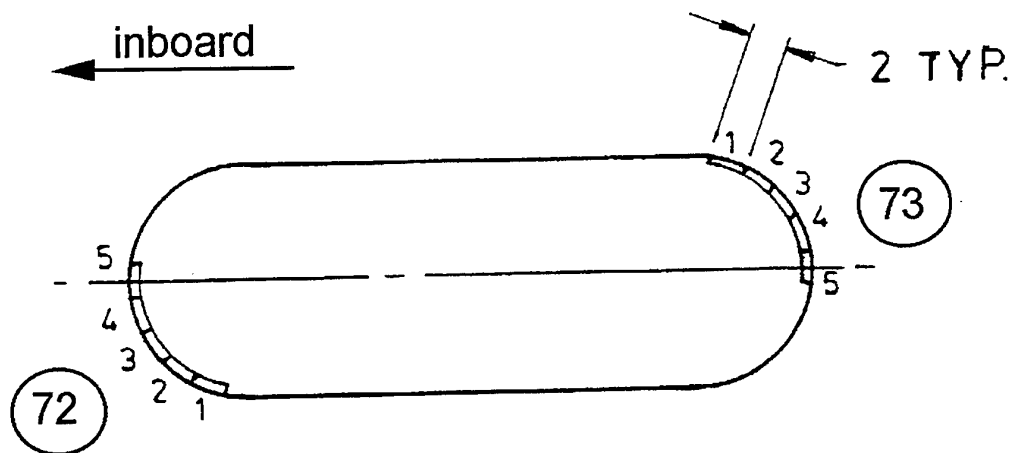
Figure 2: Location of Kyowa strip gauges number 72 & 73 on the bore of FFVH13.

The strain locations relevant to this report were for gauges 72 & 73 in Reference 2 (see Figures 2 & 4). Gauge 72 is the more critical of the two, being at the lower inboard corner of FFVH13, and its output was used as the target for the FFVH13 plate specimen of this report.

The relevant strain gauges used in the Reference 2 survey were Kyowa¹ brand, type KFG-1-120-D9-11N10C2, consisting of five elements each of 1mm length and 2mm pitch with gauge elements parallel to the strip.

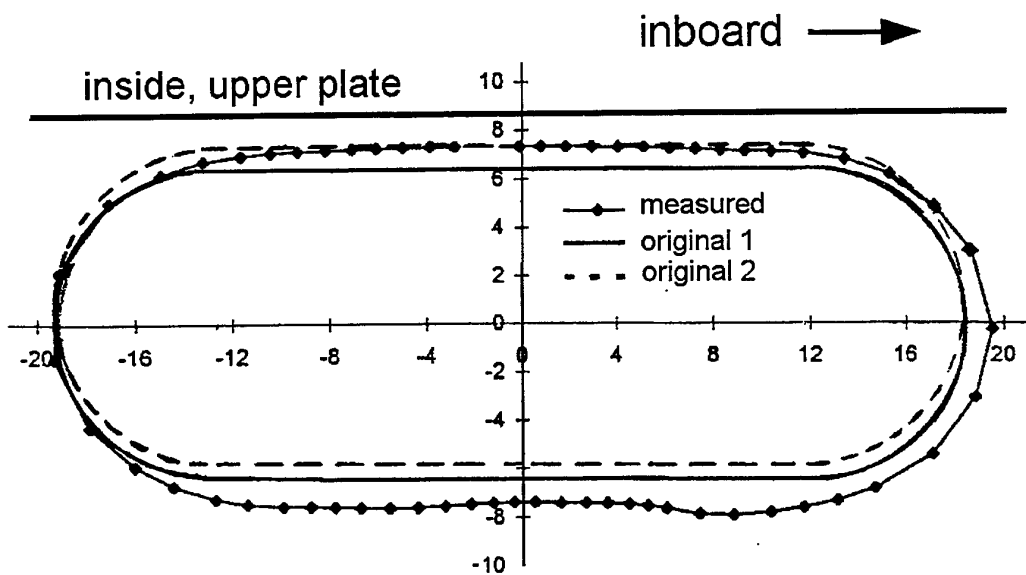
Figure 3: Measured shape of FFVH#13 compared with the original blueprint mousehole shape in two possible locations.

The exact overall dimensions of the FFVH13 in the test wing were recorded in Reference 2 and are presented in Figure 3 compared with two possible blueprint original locations - "original 1" is considered to be the most likely position of the original hole. The nominal blueprint overall dimensions of the hole are 1.5 inch x 0.5 inch (38.1 mm x 12.7 mm). This would mean that a 10 mm long strip gauge would take up the complete quarter radius as shown in Figure 2 and Figure 4, from Reference 2.

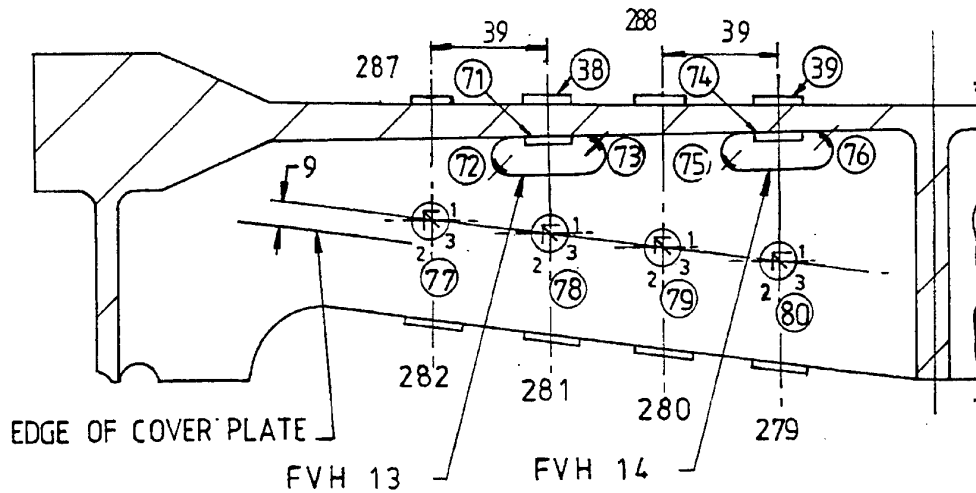
Figure 4: Location of FFVH13 in relationship to the surrounding structure and gauges [3]

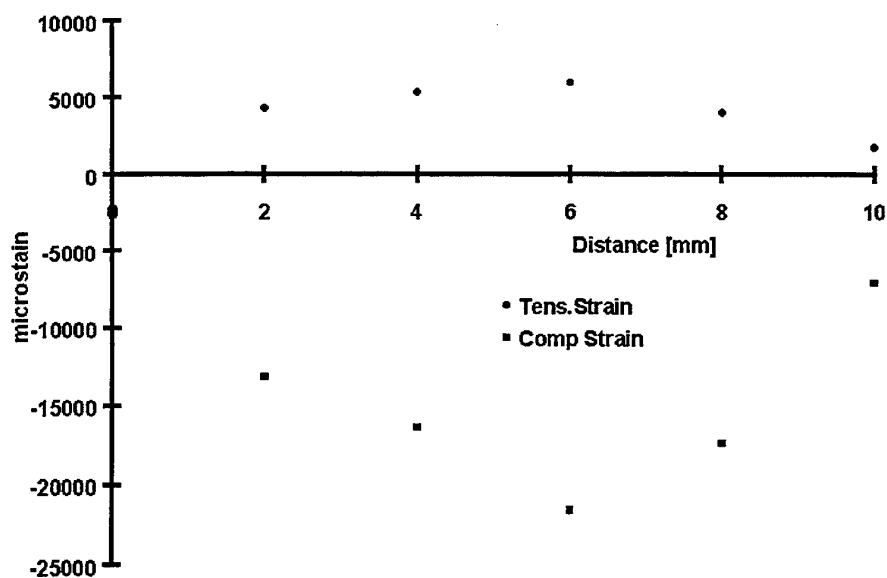
Figure 5: Strains around FFVH13 as a function of distance along strip gauge

Figure 5 presents the wing strain results from Reference 2 for gauge 72 for the two load cases under consideration - CPLT UP (compressive strain) and CPLT DOWN (tension strain). Of interest is that the strains remain all of the same sign for a given load case - something that proved different to the test specimen (Section 6).

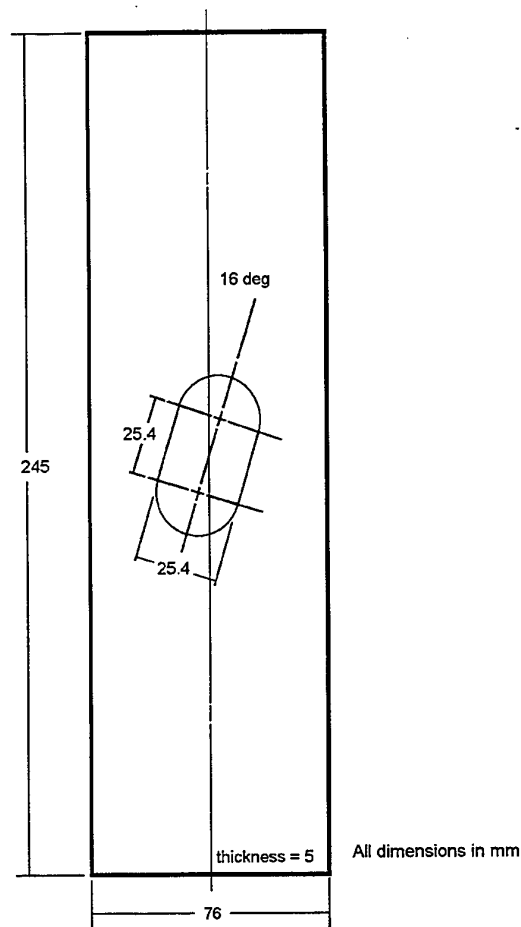
Figure 6: Geometry of test specimen

A test specimen design existed from prior analysis. Figure 6 gives the dimensions of the specimen. The design was such that it would:

1. represent the stresses existing in the FFVH13 (see Reference 4); and
2. represent a plug size that would cover the majority of the current F-111 fleet size and shape configurations of FFVH13.

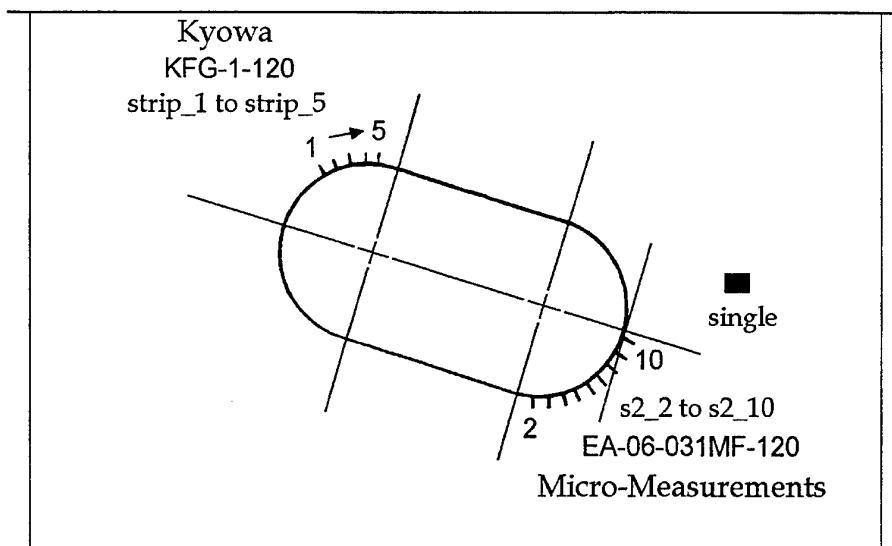
Figure 7: Strain gauge locations on specimen

Strain gauges were fitted to the test specimen as shown in Figure 7. A Kyowa strip gauge is shown in the top left radius of the hole, numbered "strip_1" through to "strip_5". A Micro-Measurements³ strip gauge is shown in the bottom right radius, numbered "s2_1" through to "s2_10". Gauge elements s2_1, s2_3 & s2_6 were inoperative through the test. Elements s2_3 & s2_6 were damaged during installation (Micro-Measurements strip gauges do not come pre-wired and are therefore more susceptible to damage), and s2_2 failed prior to test for an unknown reason. This meant there was no gauge at the critical point in the hole for the MM strip gauge.

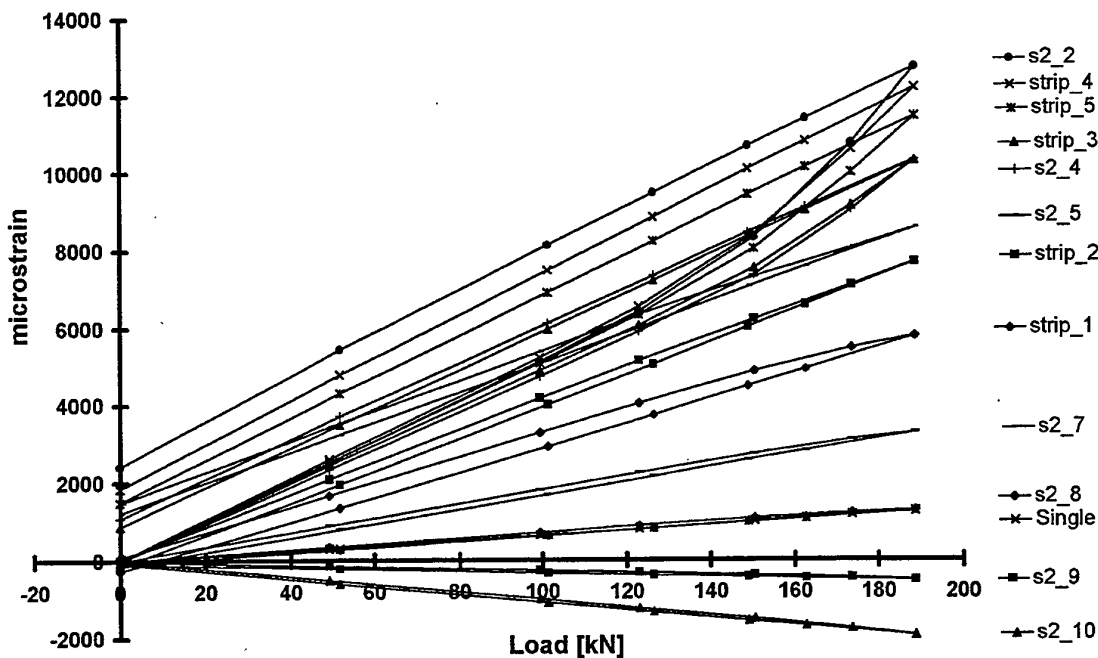
Figure 8: Strain vs load results for all strain gauges during tension loading. Strip_i denoted Kyowa gauges. s2_i denotes Micro-Measurements gauges. The single gauge is a Micro Measurements gauge.

The results for all strain gauges during the tension cycle of the loading are shown in Figure 8.

The Kyowa gauge "strip_4" and the Micro-Measurements gauge "s2_2" gave the highest gauge readings at each location, though these values are unlikely to be the maximum value experienced on the hole radius. The full set of strain data from the

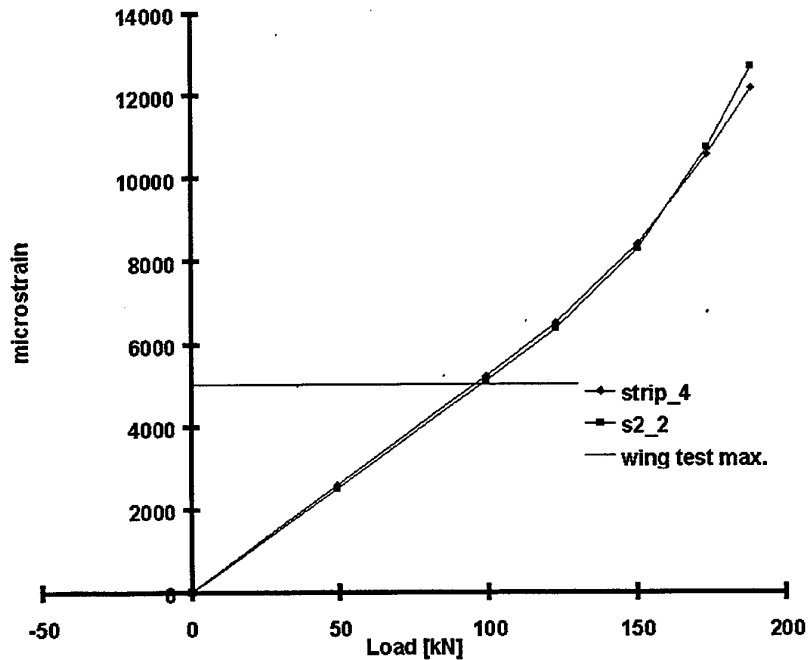
Figure 9: Response of gauges s2_2 and strip_4 during tension loading compared to the maximum seen during wing test in Figure 7.

tension and compression tests is given in Tables 3 and 4. For the tension data in Table 3 the response of these gauges are compared in Figure 9 to the maximum of $5045 \mu\epsilon$ (= $5998 \mu\epsilon - 953 \mu\epsilon$) seen during the static test of the wing in CPLT DOWN loading case.

From Figure 9, it can be seen that some plasticity exists after about 100kN load, which also corresponds to the point where the wing strain is reached.

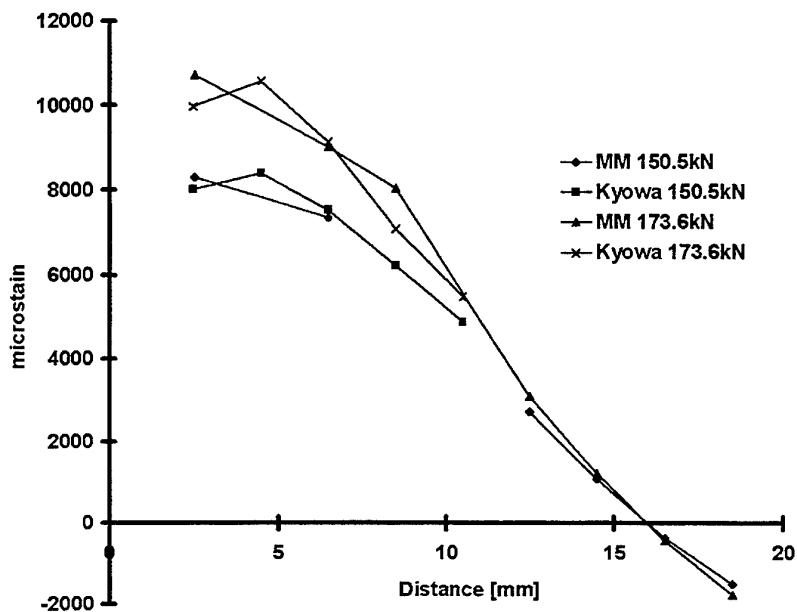
Figure 10: Tension strain versus gauge distance from tangent point - Kyowa & Micro - Measurements strain gauges. Loads 150.5kN & 173.6kN

At the load levels of 150.5kN and 173.6kN, the strain distributions around the hole radii were as shown in Figure 10. This indicates that the Kyowa and Micro-Measurements gauges were giving good correlation to points above yield onset. It also indicates that the strain distribution around the specimen hole goes negative - something that does not occur with the wing strain gauge (compare to Figure 4).

Note : the wing strain gauge is the same length as the Kyowa gauge, but the wing hole is of smaller radius.

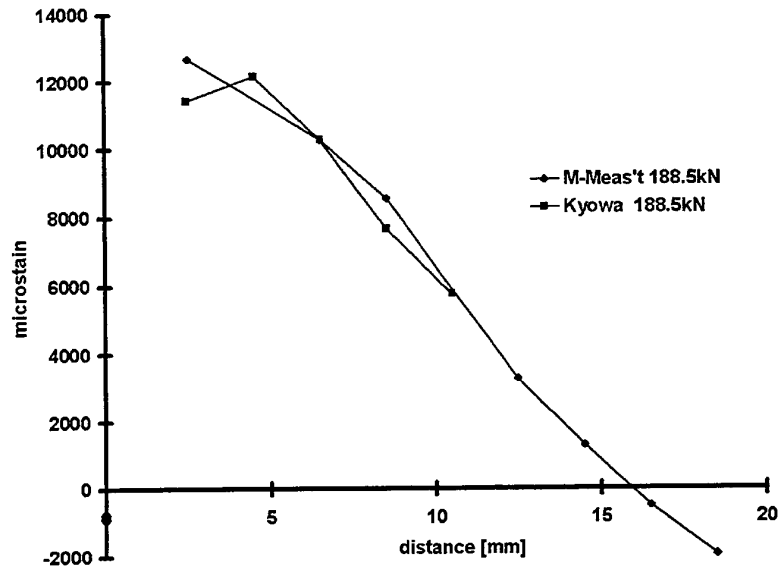
Figure 11: Maximum tension strain versus gauge distance from tangent point - Kyowa & Micro - Measurements strain gauges.

After yielding and at the maximum tensile strain point, the results are shown in Figure 11. This shows that one end of the hole is experiencing higher strains - possibly due to slightly different material properties influencing a different yield onset.

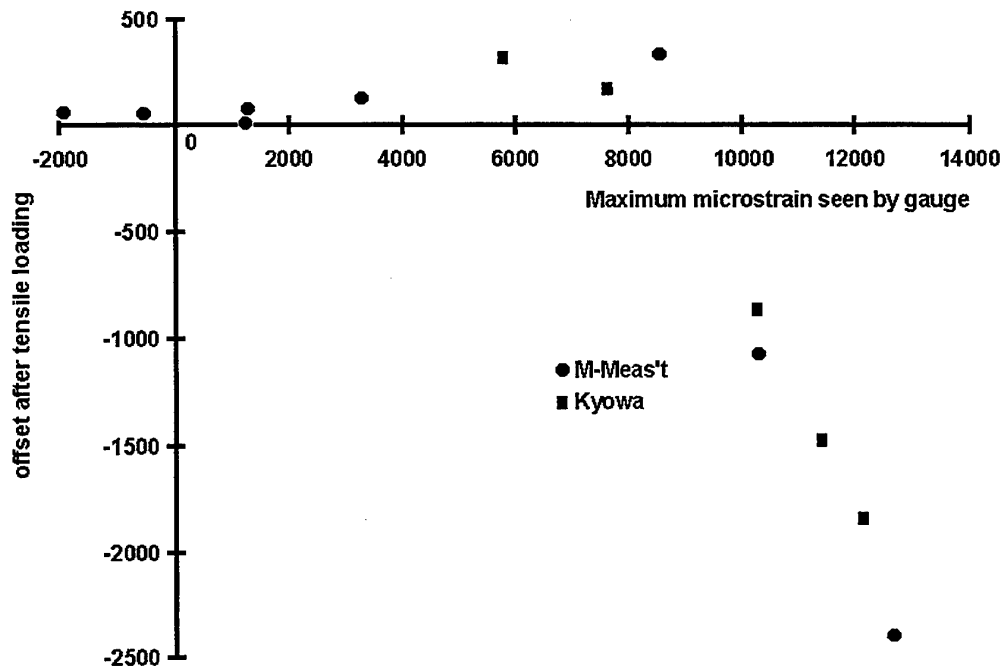
Figure 12: Gauge offset versus maximum strain seen by gauge during tension loading

The reason for using both Kyowa and Micro-Measurements gauges in the same, but opposite locations was to determine the differing (if any) responses of the gauges after removal of the load. Figure 12 plots the gauge offset after removal of the tensile loading. There is no reason to suspect any difference between Kyowa and Micro-Measurements gauges based on this limited information. The compressive cycle is more severe, and could show a difference.

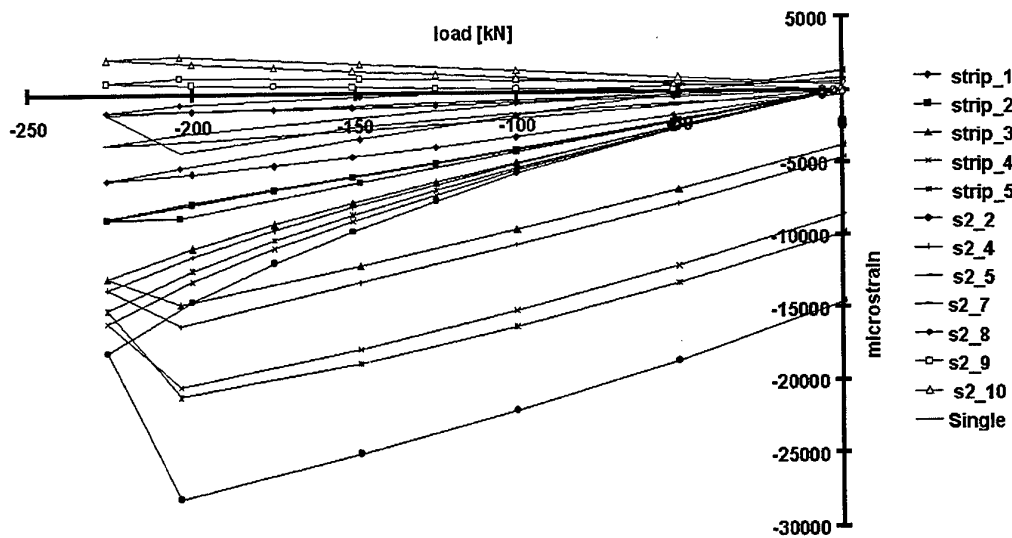
Figure 13: Strain vs load results for all strain gauges during compression loading. Strip_x denotes Kyowa gauges. s2_z denotes Micro-Measurements gauges. The single gauge was a Micro-Measurements gauge.

Gauges were zeroed at the beginning of the compression cycle as the data acquisition system needed to be re-calibrated because of the aforementioned error. Results cannot be looked at in isolation - all gauges having a degree of offset indicated in Figure 8 and Figure 12. Figure 13 presents the strain results during the compressive cycle, with Figure 14 presenting the same data of strains occurring up to buckling.

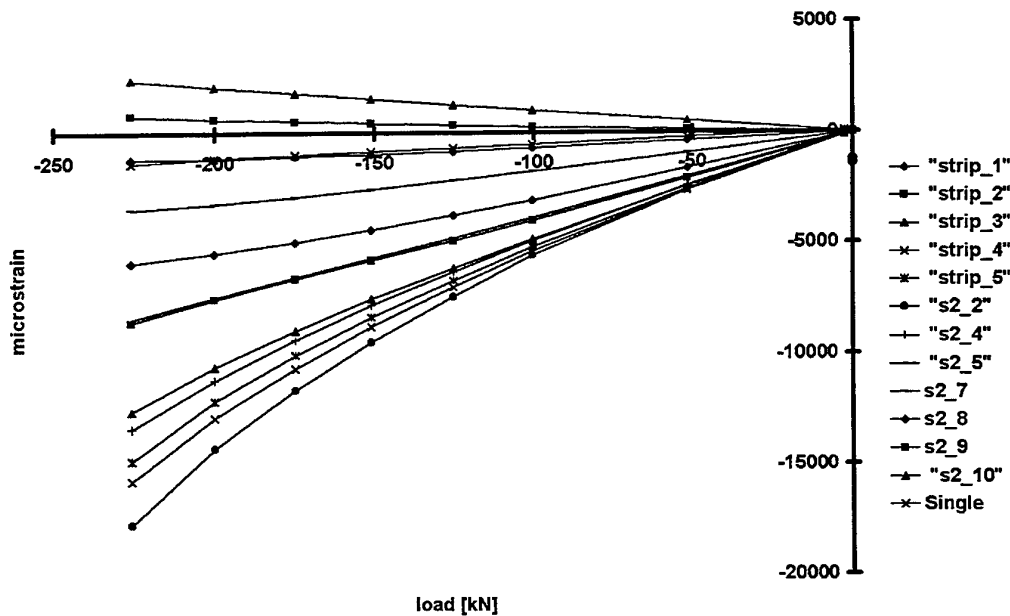
Figure 14: Strain vs load results for all strain gauges during compression loading up to point of buckling. Strip_x denoted Kyowa gauges. s2_z denotes Micro-Measurements gauges. The single gauge is a Micro-Measurements gauge.

The strip gauge element s2_2 reached a strain of $-17776 \mu\epsilon$ at -226 kN - the last measurement before buckling at approximately 248 kN . As the gauges had been zeroed, an additional strain equal to the gauge offset at the end of the tension loading should be added. This additional value is $2410 \mu\epsilon$.

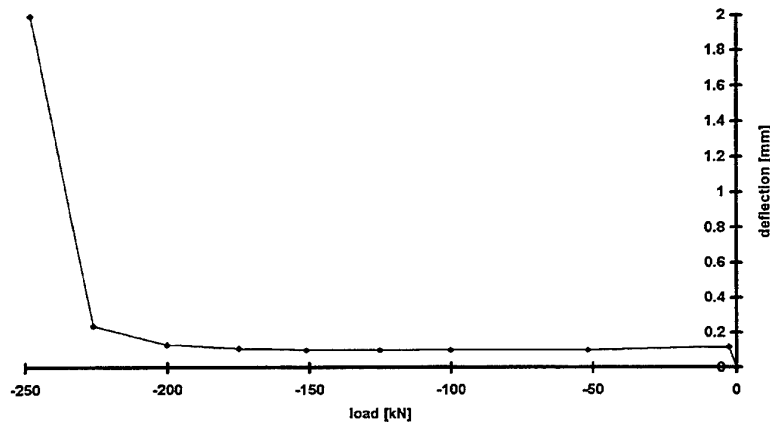
Figure 15: Load vs out of plane deflection showing onset of buckling

The test specimen reached a load of 248 kN . This was a lot lower than the value predicted, so it came as a surprise. Figure 15 shows the out of plane deflection versus load during the compressive cycle.

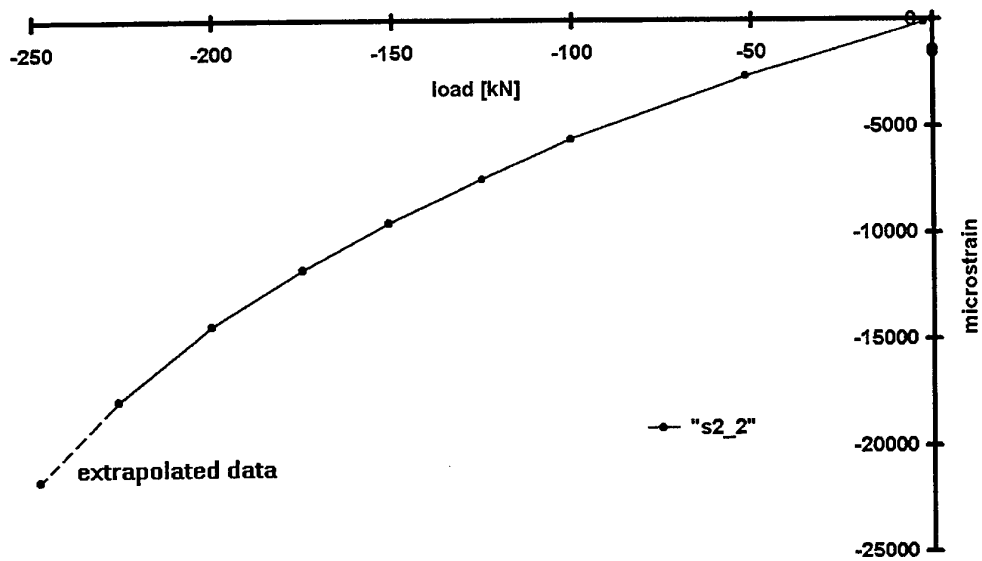
Figure 16: Load vs strain at gauge element s2_2 showing extrapolated data (if no buckling had occurred)

The response of gauge element s2_2 is given in Figure 16 with the line extrapolated out to 250 kN . It is easy to see that the specimen was very close to reaching the target $21549 \mu\epsilon$.

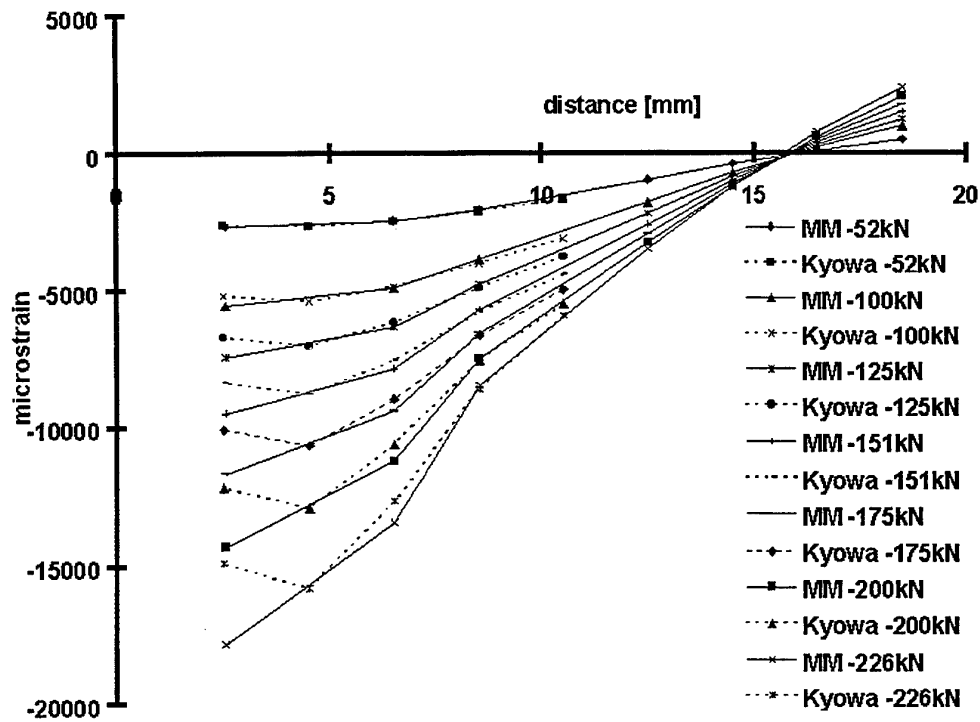
Figure 17: Strain gauge comparison between Kyowa and Micro-Measurements gauges at different load steps.

The response of the Kyowa and Micro-Measurements gauges can be compared side-by-side as shown in Figure 17 at different load values. Values are plotted around the radius with the zero being the tangent between the radius and the flat side of the hole.
